Serial No. **09/533,904**

For: **COOKING CELLULOSE MATERIAL USING HIGH  
ALKALI CONCENTRATIONS AND/OR HIGH PH NEAR  
THE END OF THE COOK**

**RULE 132 DECLARATION OF C. BERTIL STROMBERG**

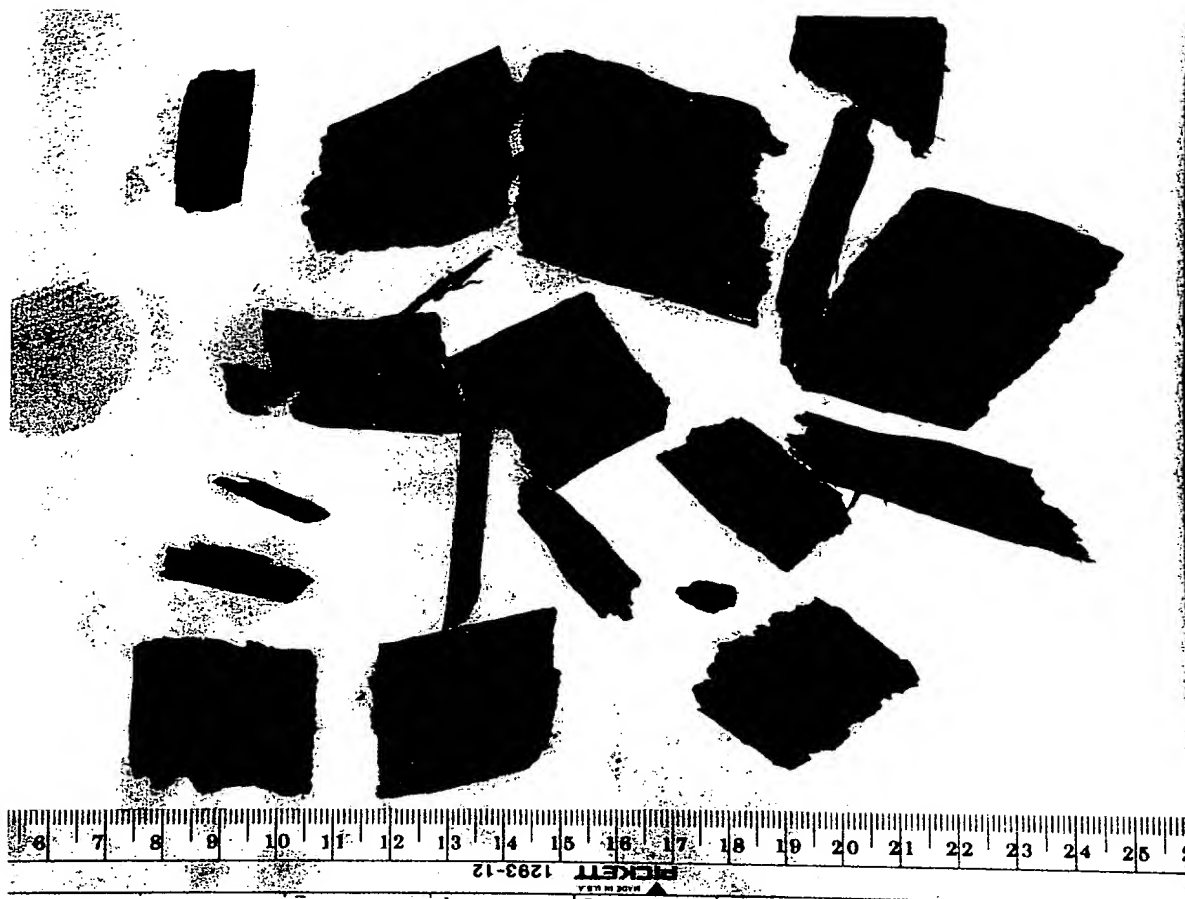
Figure 7. Southern pine chips after impregnation.

10. Figures 6 - 8 are photographs of the wood chips after treating for 30 minutes at 110°C (the impregnation stage) where the effective alkali concentration at the beginning of the impregnation stage was 54.9g/l as NaOH.

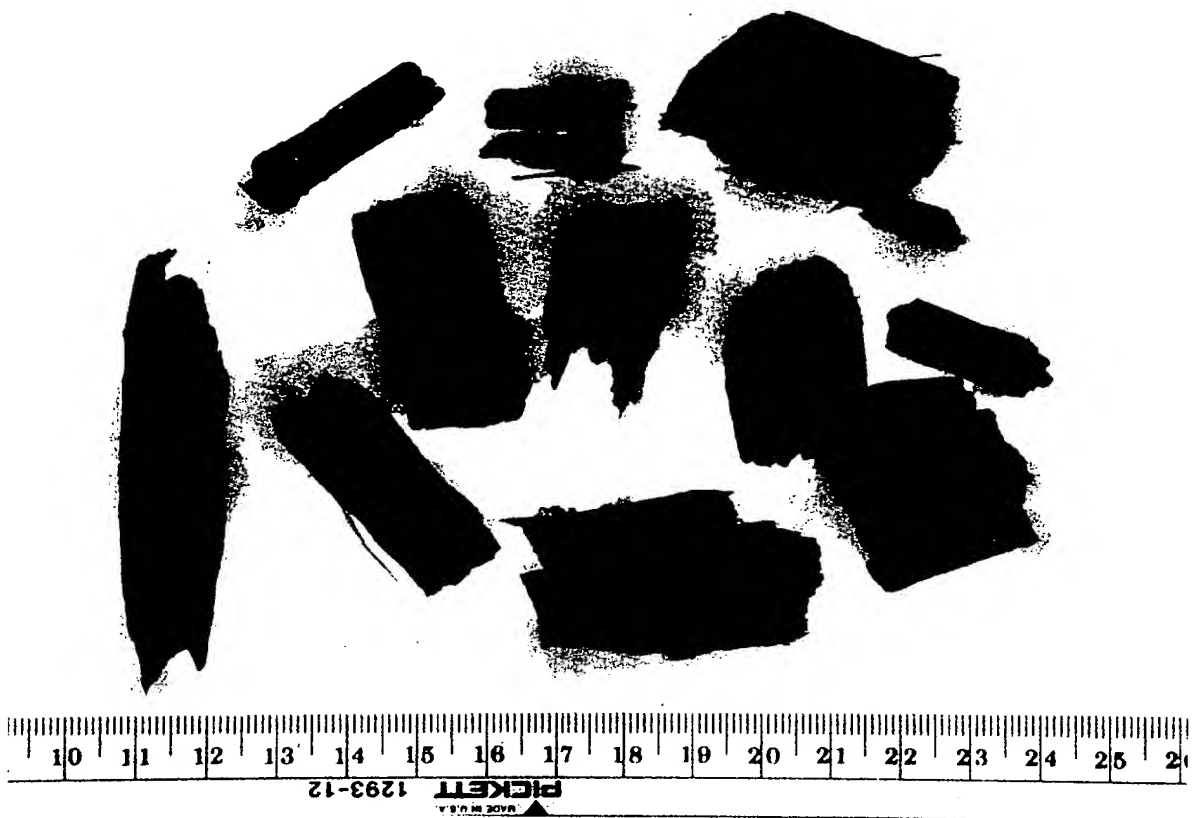
Figure 10. Southern pine chips mid-way through the cook zone.

11. Figures 9 -11 are photographs of the wood chips at the mid-point of the cook, 15 minutes to reach the final cooking temperature of 168.6°C and 43 minutes at the final cooking temperature. The effective alkali concentration was measured as 12.8g/l at the mid-point of the cooking stage.

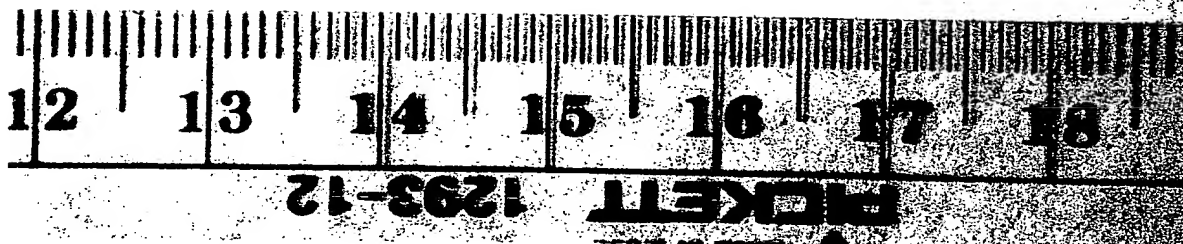
Figure 11. A single Southern pine chip mid-way through the cook zone.
